**DECLARATION OF KYLE LUTZ IN  
SUPPORT OF DEFENDANTS'  
MOTION TO DISMISS OR, IN THE  
ALTERNATIVE, MOTION FOR  
SUMMARY JUDGMENT**

## Travis Moreda Dairy List of Improvements

# Representative Photographs of Improvements

### CONFINED ANIMAL FACILITY COMPLIANCE INSPECTION

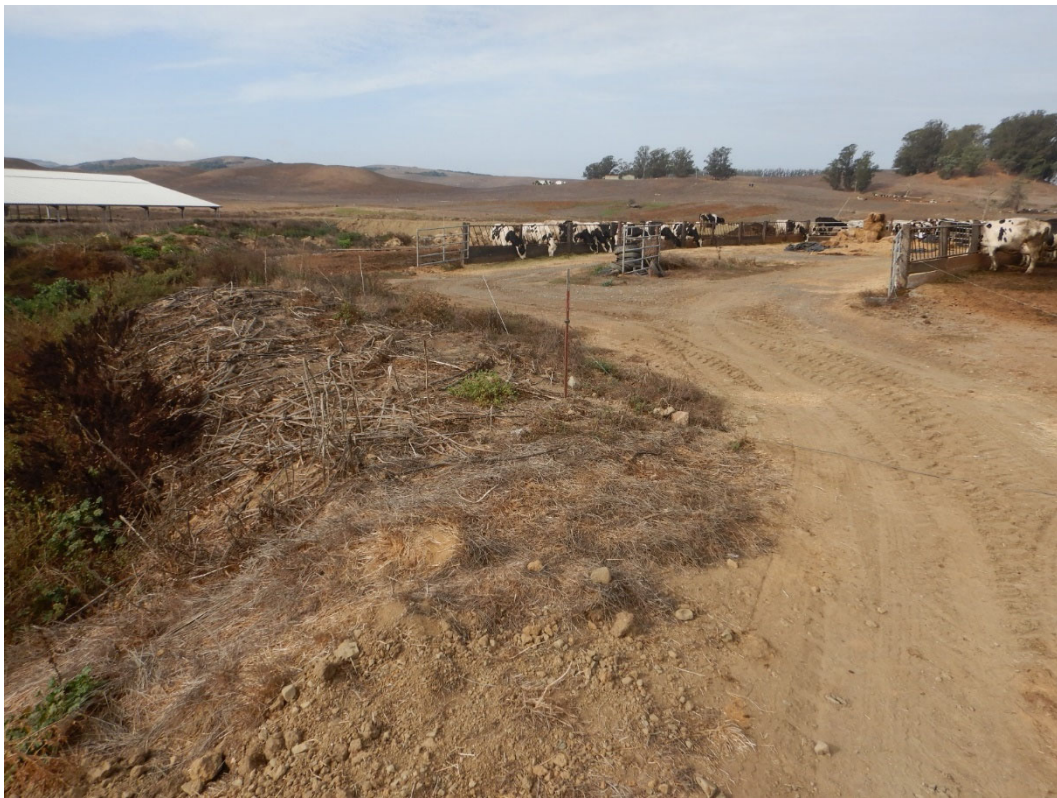
Photo 9: Edge of Ponds 3 and 4 on left of photo, feed area on right.

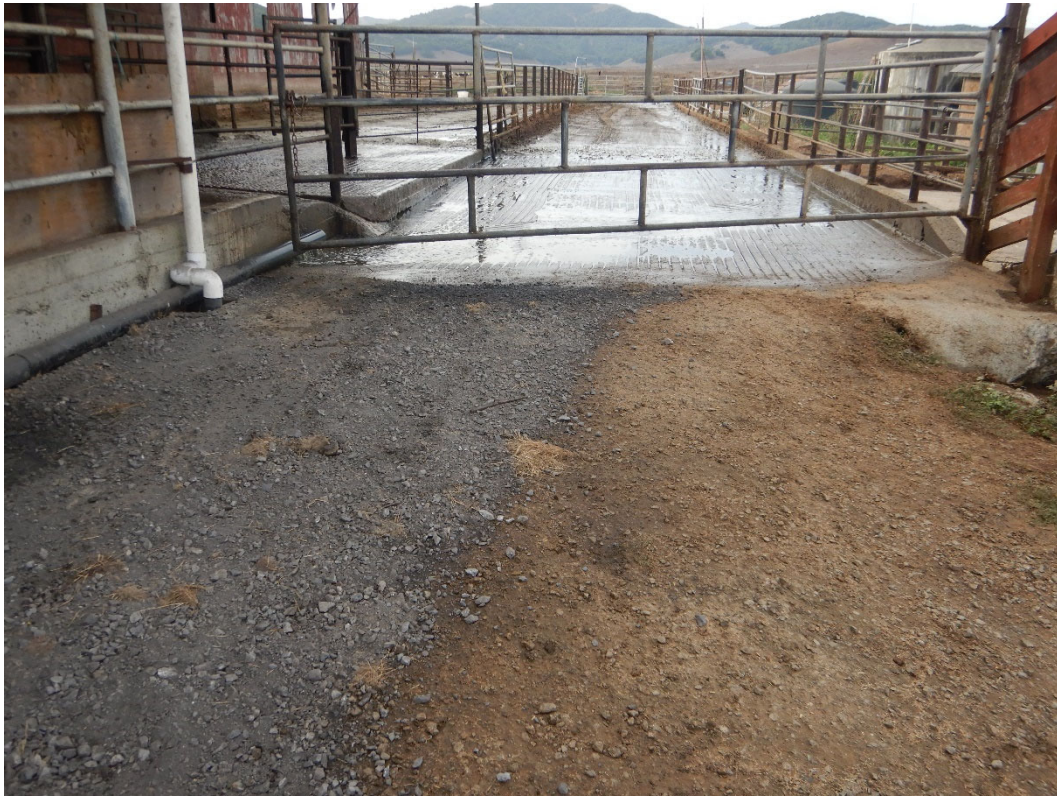
Photo 10: Edge of north barn that is graded to drain towards waste pond system. The gradient is visibly effective at containing wastewater. In the left of photo, the gutter downspout outlet is protected with gravel.

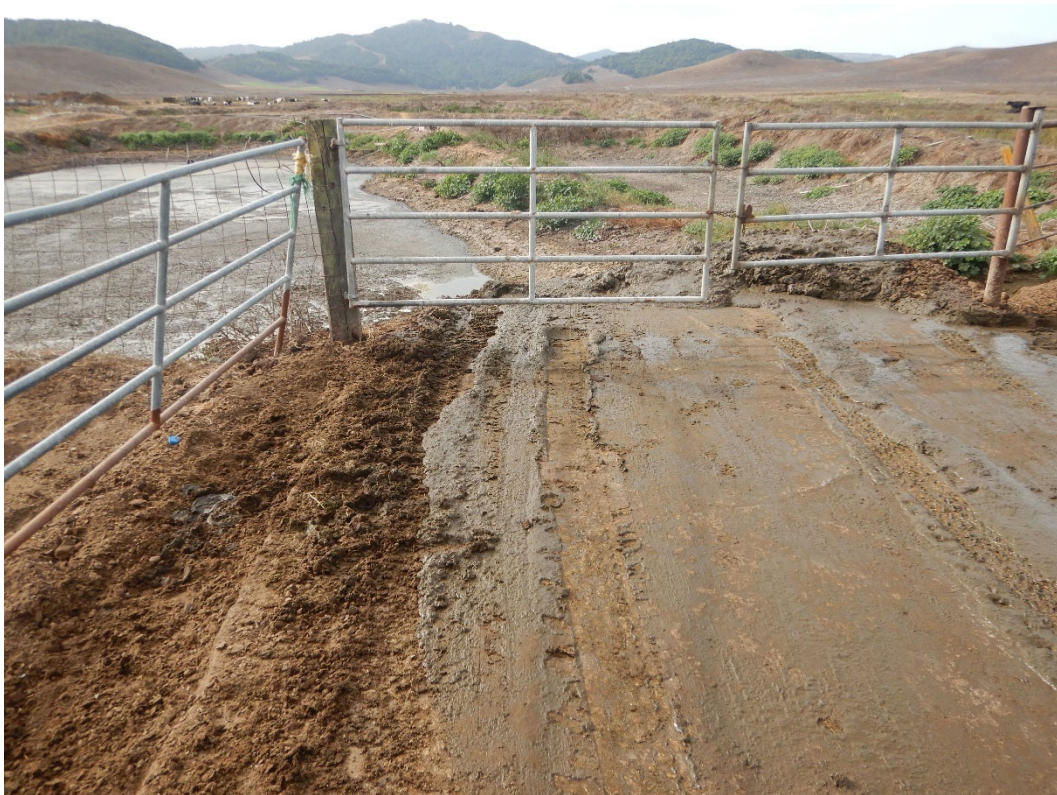
<b>Comments:</b> Operator maintains records of berm and pond integrity and capacity inspections. Pond 1 can be seen in the background of Photo 11, Pond 3 is in Photo 4, Pond 4 and 5 are in Photos 14 and 15 respectively.

Photo 11: North barn and corral that empties into Pond 1.

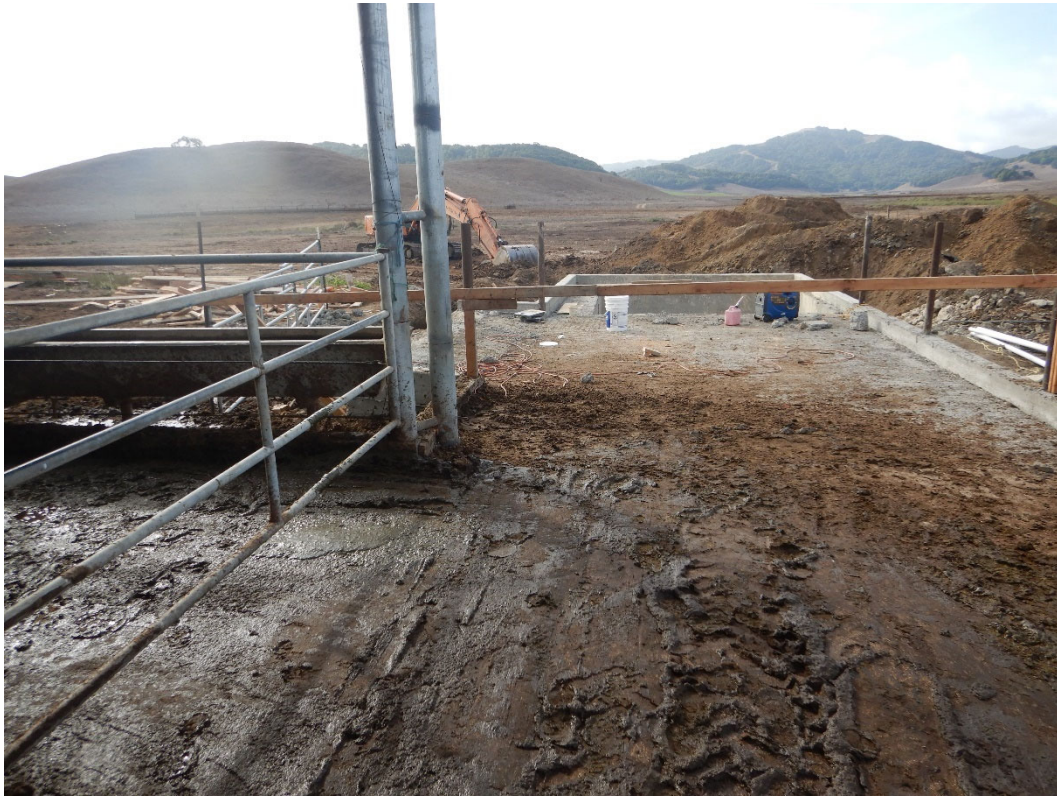
Photo 12: Southern barn drains into a concrete collection pit (under maintenance) that connects to the waste pond system.

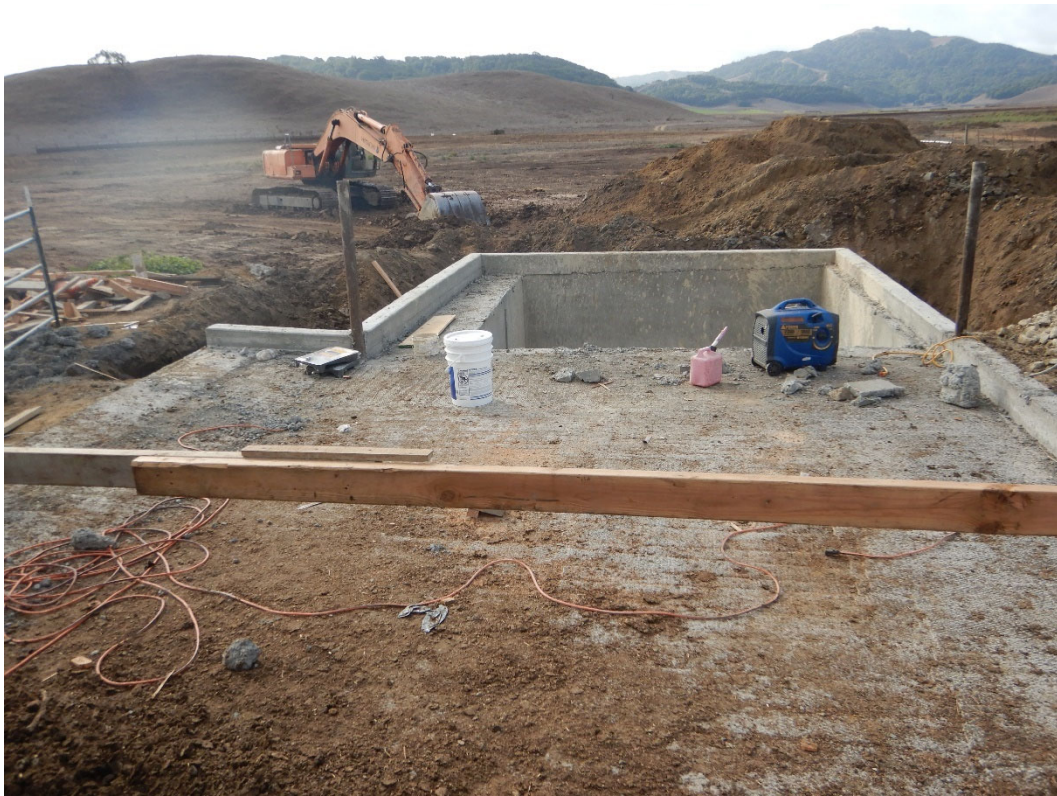
Photo 13: Collection pit for southern barn.

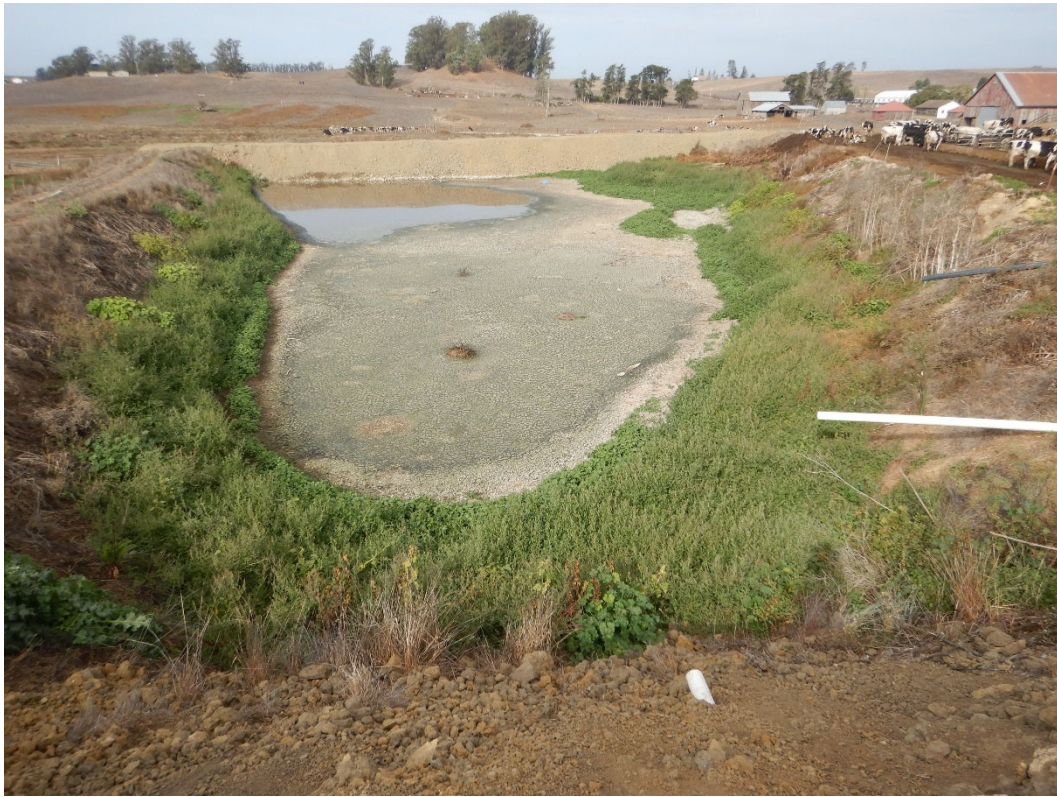
Photo 14: Pond 4 with gravity fed pipelines from Pond 3 (right) and to Pond 5 (bottom).

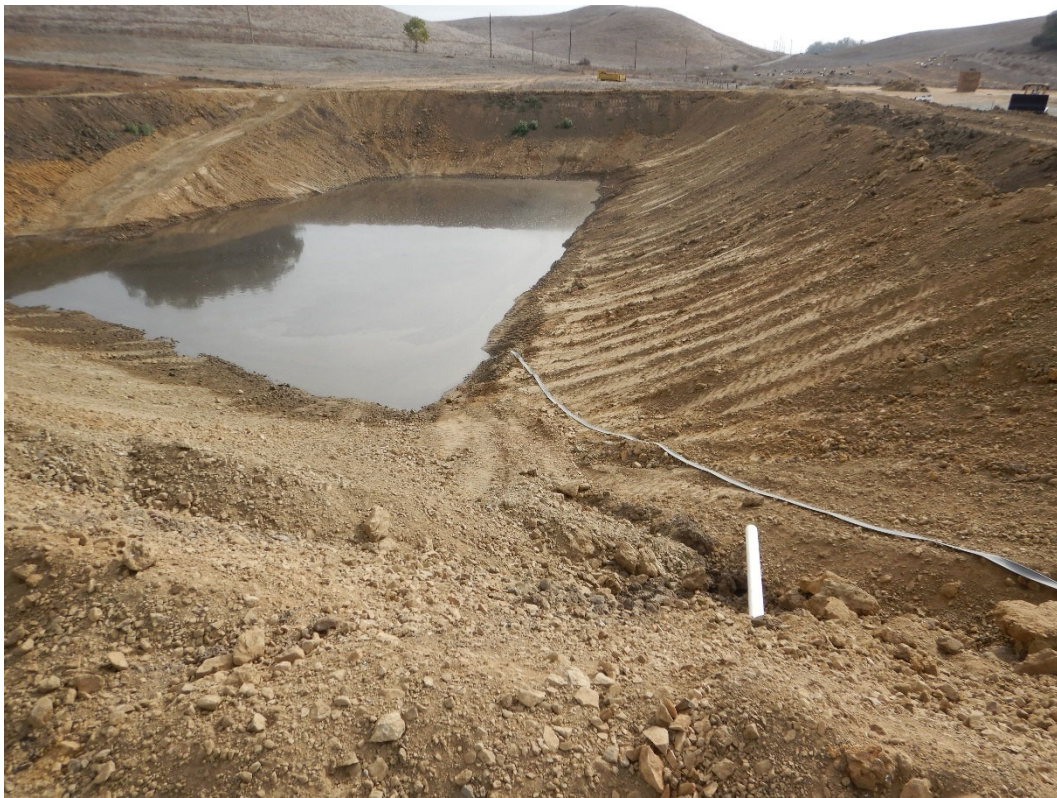
Photo 15: Pond 5 with gravity fed pipeline from Pond 4.
